**Intermountain Power Service Corp.  
ABT Siemens Warranty Claim**

Unit #2 - 950 MW

Plant Location – Delta Utah

Date: October 17, 2007

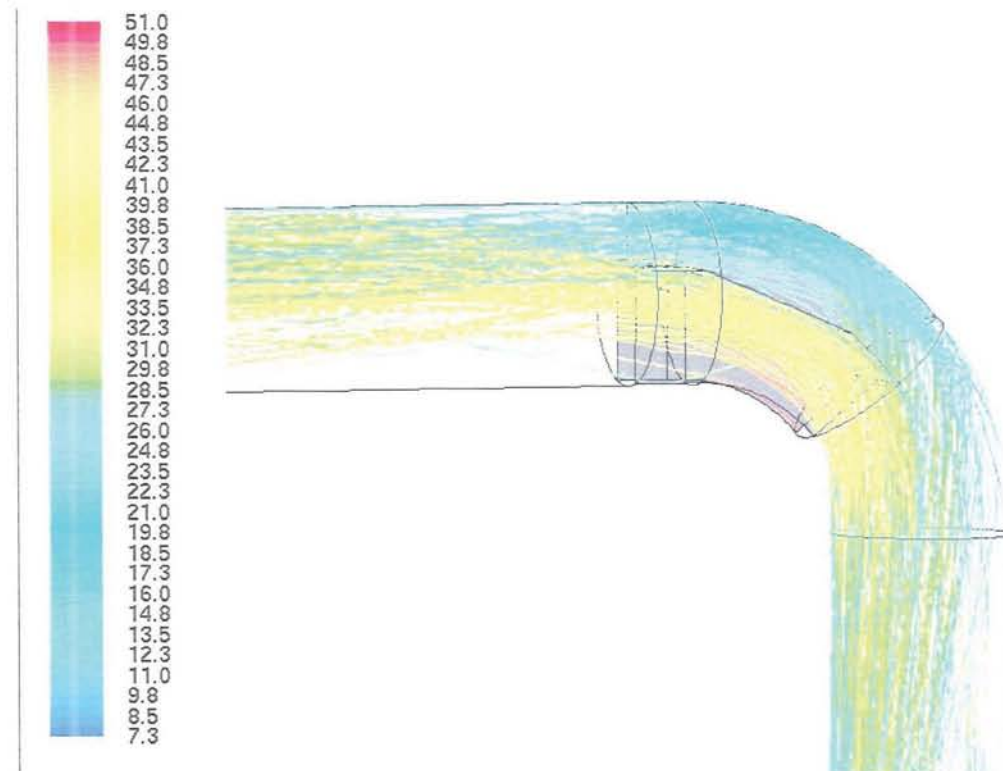
The CFD model shows the coal particles are stratified entering the elbow. The original kicker assembly with the X-vane that was modified to retain the clean out port will not last in the high velocity stream of concentrated coal particles with the higher coal flow.

The revised fuel injector design will increase the cross sectional area of the nozzle to reduce velocities, lengthen and flatten the slope of the transition ramp and replace the round elbow with a "Flat back" design to allow dispersion of the coal particles across the flow area of the nozzle.

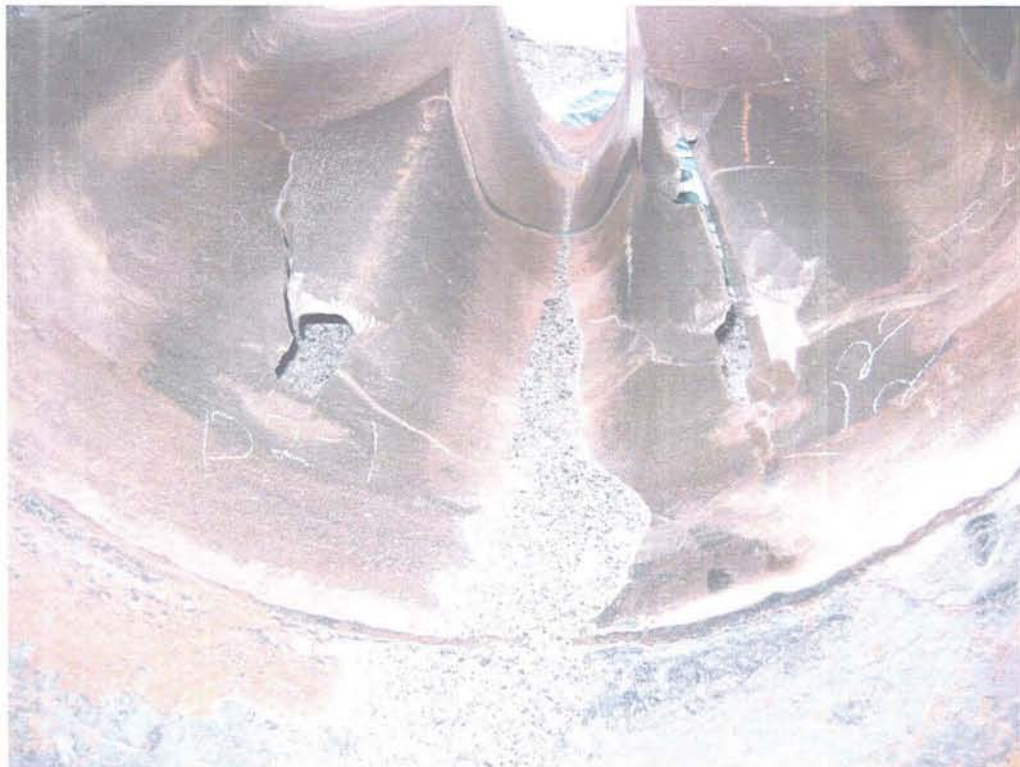
Erosion is originating at the transition slope from the round barrel to the 6 lobe exit. This is consistent with the results of the CFD model. The metallurgical analysis performed by Tordonato Energy Consultants identified erosion as a the contributor cause of the nozzle cracking. The high temperatures at the weld between the nozzle and burner barrel increased the stress which also contributed to the cracking. There was no evidence of corrosion.

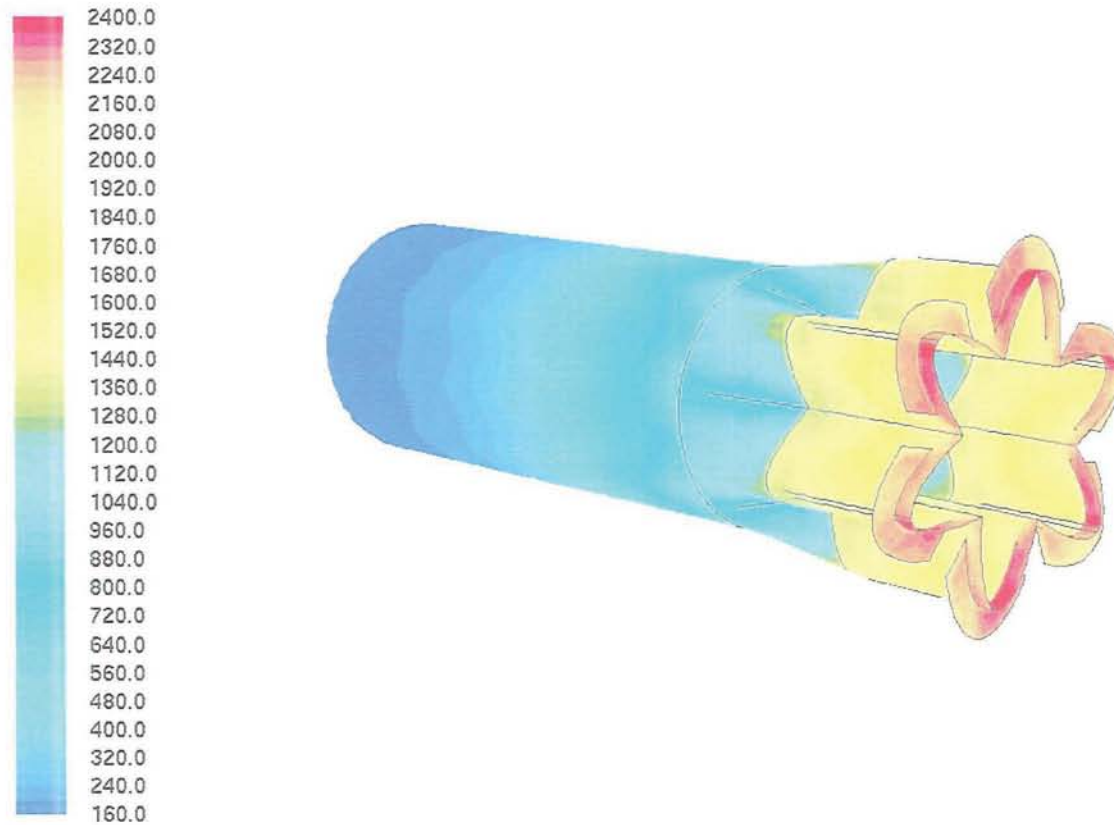
Contours of Static Temperature (f)

The furnace radiation model shows that the heat conducted back to the burner barrel to be higher than expected. The revised fuel injector will use a spool piece of 253MA stainless steel to make the transition from the nozzle to the barrel. The revised fuel injector shall use refractory tile to shield the burner barrel from radiation from the furnace and to minimize erosion. This thermal model does not model the cooling of the secondary air on the tip.
